## Radiographically Occult Right Main Bronchus Intubation with a Fastrach Laryngeal Mask Airway Endotracheal Tube

Jon S Huseby MD and Steven Legault RRT

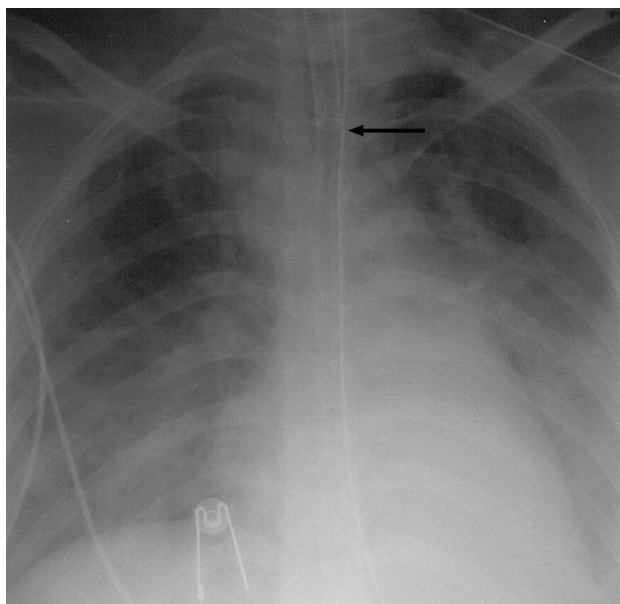
Fig. 2. Radiograph after repositioning endotracheal tube (ETT). The wire coil in the ETT (arrow) ends at the clavicular level so that the end of the ETT is 2 cm above the main carina. Atelectasis is resolving.

Undoubtedly our patient's small size increased the possibility of bronchus intermedius intubation. When the ETT was in good position, 2 cm above the main carina by direct observation, the radiograph showed the wire coil ending at about the clavicular level. Anesthesiologists, emergency department personnel, critical care physicians, and respiratory therapists should be aware of this potential complication; we believe the manufacturer should redesign this ETT to include a better radiopaque marker all the way to the end of the ETT.

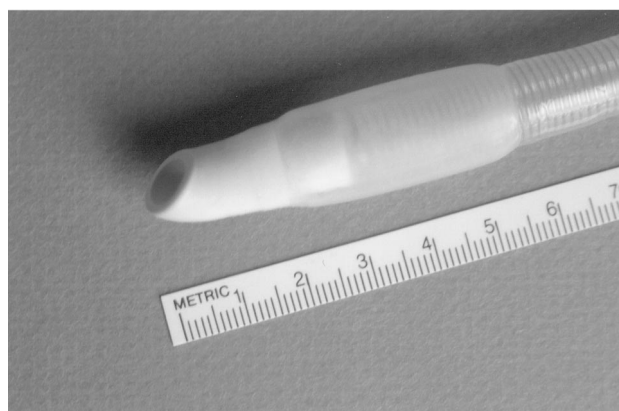
by blindly passing an ETT through the LMA. On direct examination of the LMA-Fastrach ETT (Fig. 3), the problem became apparent. The wire coil, which gives the ETT flexibility while preventing collapse, ends 3 cm from the distal end of the ETT. The 3 cm tip is made of silicone rubber, and though it has radiopaque markers on both sides, all the way to the end of the tube, these are easily missed on chest radiograph. In other ETTs of the same

Fig. 3. LMA-Fastrach laryngeal mask airway endotracheal tube. Note that the wire coil built into the tube ends 3 cm before the end of the tube.

basic design (eg, Rüsch) the wire extends much closer to the end of the ETT. This problem has been previously reported in the case of a patient intubated with a #7 Mallinckrodt ETT,<sup>2</sup> so this may be a generic problem with several armored tubes.
